# Assessment of Scour-Induced Damage and Service Life Prediction of a River Bridge Based on Bridge Management System

This study assesses the condition of the Sungai Salak Bridge (Sungai Taib Village, Kotabaru Regency) using a visual inspection approach based on the Indonesian Bridge Management System (BMS) procedure. The objective is to identify damage levels at the element and system levels and to provide maintenance-oriented recommendations for a riverine bridge affected by erosion, landslide, and settlement processes. Field observations and BMS scoring indicate that several critical elements have reached severe deterioration, particularly the protective works (retaining structures), arch-related components, railings, and bridge accessories, while the deck system and several crossing elements remain visually intact. The BMS evaluation yields an average condition value of  $NK = 3$ , classifying the bridge as damaged, with an equivalent service age estimate of approximately 41 years. Visual evidence suggests that scour-induced erosion and embankment instability have contributed to progressive loss of protection and displacement of structural components, including lateral movement

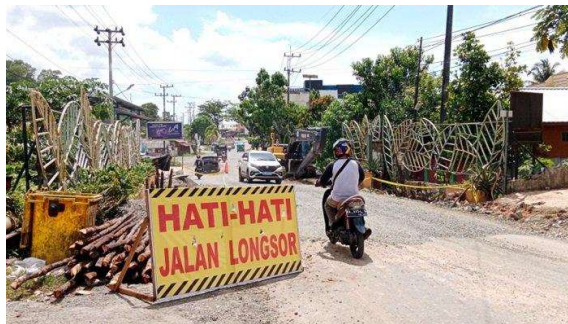
Visual documentation was used to support interpretation and to provide context for field conditions. Figure 2 presents the temporary condition of the Sungai Salak Bridge following slope instability and post-event emergency handling. The warning signage and the visible road deformation indicate the presence of landslide-related disruption and likely settlement processes along the approach, which are consistent with riverbank erosion and settlement phenomena reported in the literature for riverine infrastructures (Arora et al., 2023; Yang et al., 2024).

**Figure 2** Temporary condition of the Sungai Salak Bridge

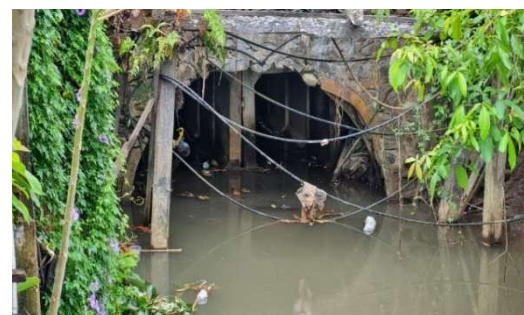
The structural symptoms observed in the field support a scour-induced deterioration mechanism. Figure 3 shows erosion at the A1 arch element (Code 3.430), where foundation stones have been undermined due to river flow velocity. This condition is consistent with local scour processes that reduce foundation embedment depth and compromise bearing resistance (Deng & Cai, 2010).

**Figure 3** Scour-induced erosion at arch element (A1)

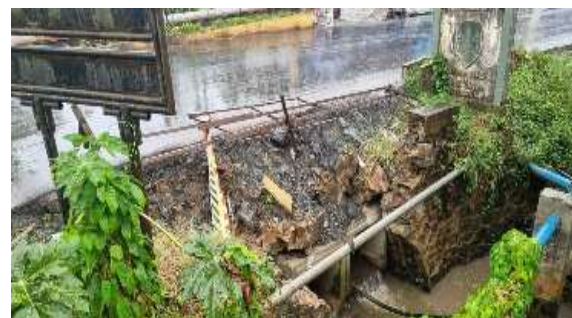
Figure 4 illustrates partial collapse at the A2 arch segment, indicating progressive instability likely initiated by foundation undermining and embankment settlement.

**Figure 4** Arch failure due to settlement and slope instability
