# Condition Assessment and Remaining Service Life Evaluation of a Steel–Concrete Composite Bridge Using BMS and BCI WSDOT Methods

Cikondang Bridge is a steel–concrete composite girder bridge located on the Cibeber–Sukanagara road section in Cianjur Regency, West Java. The bridge was constructed in 1984 and has been in service for approximately 42 years. This study aims to assess the existing condition and remaining service life of Cikondang Bridge using the Bridge Management System (BMS) and Bridge Condition Index (BCI) WSDOT methods. Primary data were collected through field visual inspection and documentation of bridge components, including the deck, steel girders, drainage system, pier, and railing. The inspection identified several defects, including corrosion on steel girders, poor drainage performance, scouring around the pier, and damage to railing elements. The BMS assessment produced a condition value of  $NK = 3$ , indicating moderate damage and the need for rehabilitation. The BCI WSDOT assessment produced a BCI value of 45, which also classified the bridge as moderately damaged. The remaining service life analysis showed an equivalent bridge age of approximately 42 yea

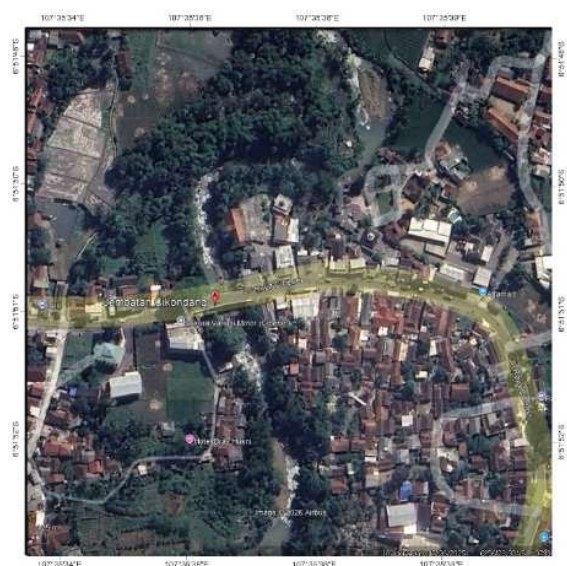
**Figure 1** Location and existing condition of Cikondang Bridge

This study was conducted on Cikondang Bridge, located on Jl. Raya Cibeber, Cibeber District, Cianjur Regency, West Java. The bridge was selected because it is still in operation and shows several visible defects on structural and nonstructural elements. The location and existing condition of the bridge are shown in Figure 1.

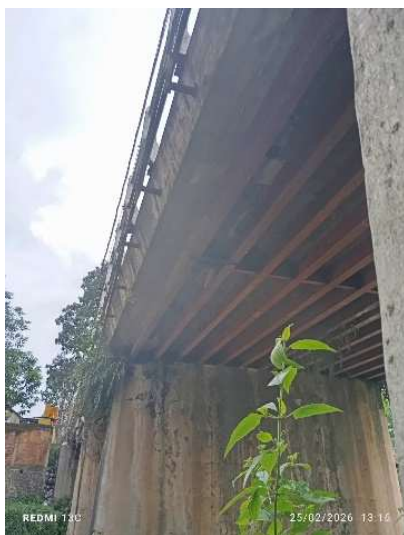
**Figure 3** Corrosion on steel girder elements of Cikondang Bridge

Corrosion was observed on several steel girder surfaces beneath the bridge deck. The affected areas showed brownish oxidation products and moisture accumulation around the lower structure. This condition indicates ongoing steel deterioration due to prolonged exposure to water and humid environmental conditions.

The corrosion mechanism is strongly associated with ineffective drainage and water retention on bridge surfaces. According to Main Roads Western Australia (2012), inadequate drainage systems significantly accelerate corrosion propagation in steel bridge elements because trapped water increases humidity and prolongs the wet-dry cycle on steel surfaces. Corrosion in steel bridge girders is critical because it may reduce section thickness and eventually decrease load-carrying capacity if left untreated.

The observed corrosion was still categorized as moderate because no major deformation or excessive section loss was visually detected. However, studies on bridge deterioration modeling indicate that corrosion propagation tends to increase exponentially after the protective coating system fails, particularly in humid environments (Hasan et al., 2015). Therefore, preventive rehabilitation is necessary to control further deterioration. Corrosion observed on the lower steel girders is shown in Figure 3.

| Element Code | Element | Damage Code | Damage Description | Location | Level 5 Condition Value | Level 3–4 Condition Value | Drawing | Photo | Emergency Action | Special Inspection/ Recommended Action |
|---|---|---|---|---|---|---|---|---|---|---|
| 4.411 | Girder | 302 | Corrosion | X = 2<br>Y = 2 | S=1, R=2,<br>K=1, F=0,<br>P=1, NK=3 | S=1, R=2,<br>K=1, F=0,<br>P=1, NK=3 | Y | Y | T | Recoating/ protective coating |

Based on the observed defects, rehabilitation should prioritize three actions. First, the drainage system should be cleaned and repaired because poor drainage can prolong moisture exposure and accelerate deterioration of bridge deck and steel components. Second, corroded steel girders should be cleaned, protected, and recoated to reduce further section loss, since corrosion is one of the main deterioration mechanisms affecting steel bridge members. Corrosion control for steel bridges commonly involves cleaning, protective coating, and preservation practices to maintain structural performance over the bridge life cycle (Federal Highway Administration, 2024). Third, scouring around the pier should be monitored and

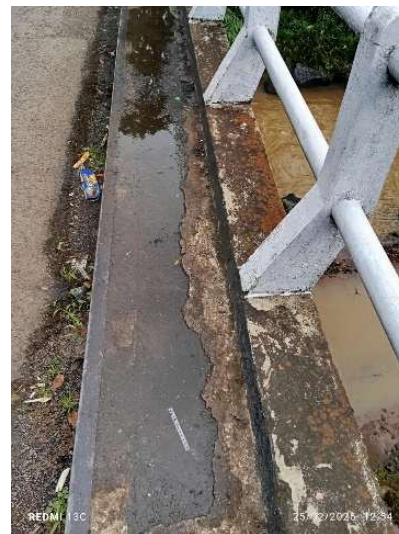
**Figure 4** Malfunctioning bridge drainage system

The bridge drainage system was found to function poorly. Water ponding and sediment accumulation were observed on the bridge surface, indicating insufficient water flow toward the drainage outlet.

Poor drainage performance plays a significant role in bridge deterioration because trapped water accelerates surface degradation and increases moisture exposure to structural elements. Agredo Chávez et al. (2024) emphasized that drainage-related deterioration is one of the dominant factors affecting bridge condition indices in bridge management systems because moisture accelerates corrosion and concrete weathering processes.

For steel–concrete composite bridges, drainage malfunction is particularly critical because continuous moisture exposure may simultaneously affect steel girders and reinforced concrete deck components. The observed drainage condition indicates the need for immediate maintenance to prevent accelerated

deterioration in adjacent bridge components. The condition of the malfunctioning drainage system is presented in Figure 4.

| Element Code | Element | Damage Code | Damage Description | Location | Level 5 Condition Value | Level 3–4 Condition Value | Drawing | Photo | Emergency Action | Special Inspection/ Recommended Action |
|---|---|---|---|---|---|---|---|---|---|---|
| 3.5 | Deck System | 204 | Component deterioration due to wear and weathering (drainage damage and water ponding identified on deck surface) | A | – | S=1, R=1,<br>K=1, F=1,<br>P=0, NK=3 | Y | Y | T | Drainage cleaning |

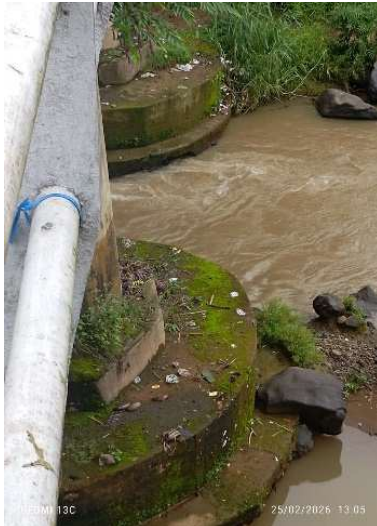
**Figure 5** Scouring around the bridge pier area

Visual inspection also identified scouring around the pier foundation caused by river flow. Soil erosion was observed near the exposed foundation area, especially at sections directly affected by water current.

Scour is considered one of the most critical hydraulic problems in bridge engineering because it can reduce foundation stability and change the response of the bridge substructure under vertical and lateral loading (Ciancimino et al., 2022).

Although no major structural instability was visually identified during inspection, the observed scour pattern indicates active interaction between the river flow and the bridge foundation. Continuous monitoring is therefore required, especially during high-flow conditions in the rainy season. Scouring around the pier foundation identified during the inspection is shown in Figure 5. Scouring around the pier is critical because it can reduce foundation capacity and change the response of the bridge substructure under vertical and lateral loading (Ciancimino et al., 2022).

Pier scouring also requires attention because continuous erosion may gradually reduce foundation stability. Although no immediate structural failure risk was identified, the observed scour condition indicates the need for periodic monitoring and hydraulic protection measures.

treated using appropriate hydraulic protection, as foundation scour can reduce the lateral capacity of bridge foundations and may lead to permanent settlement and rotation of bridge piers (Ciancimino et al., 2022). The summary of the condition assessment and remaining service life evaluation of Cikondang Bridge is presented in Table 10.

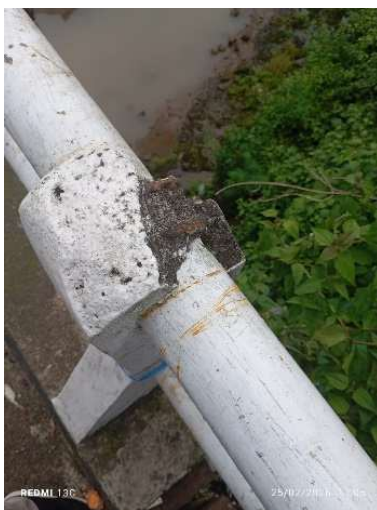
**Figure 6** Damage on bridge railing elements

Damage was also identified on the bridge railing elements, particularly at the connection and surface areas. Local deterioration and material degradation were observed on several railing components.

Although the damage does not directly affect the primary load-bearing system, railing deterioration reduces user safety and serviceability. Bridge railing systems are important safety components designed to prevent vehicle accidents and improve traffic protection. According to bridge inspection guidelines developed by Main Roads Western Australia (2012), deterioration in safety components should still receive maintenance attention even if the primary structure remains functional.

The observed deterioration was mainly associated with environmental exposure and long-term weathering effects. Therefore, local rehabilitation and protective maintenance are required to prevent further deterioration. Damage on the bridge railing elements is presented in Figure 6.

| Element Code | Element | Damage Code | Damage Description | Location | Level 5 Condition Value | Level 3–4 Condition Value | Drawing | Photo | Emergency Action | Special Inspection/ Recommended Action |
|---|---|---|---|---|---|---|---|---|---|---|
| 3.62 | Railing | 205 | Cracking or partial concrete loss | A | – | S=1, R=1,<br>K=0, F=0,<br>P=0, NK=2 | Y | Y | T | Mortar patch repair |
